Bridge Street Bridge – Status on September 1, 2013, 13:00

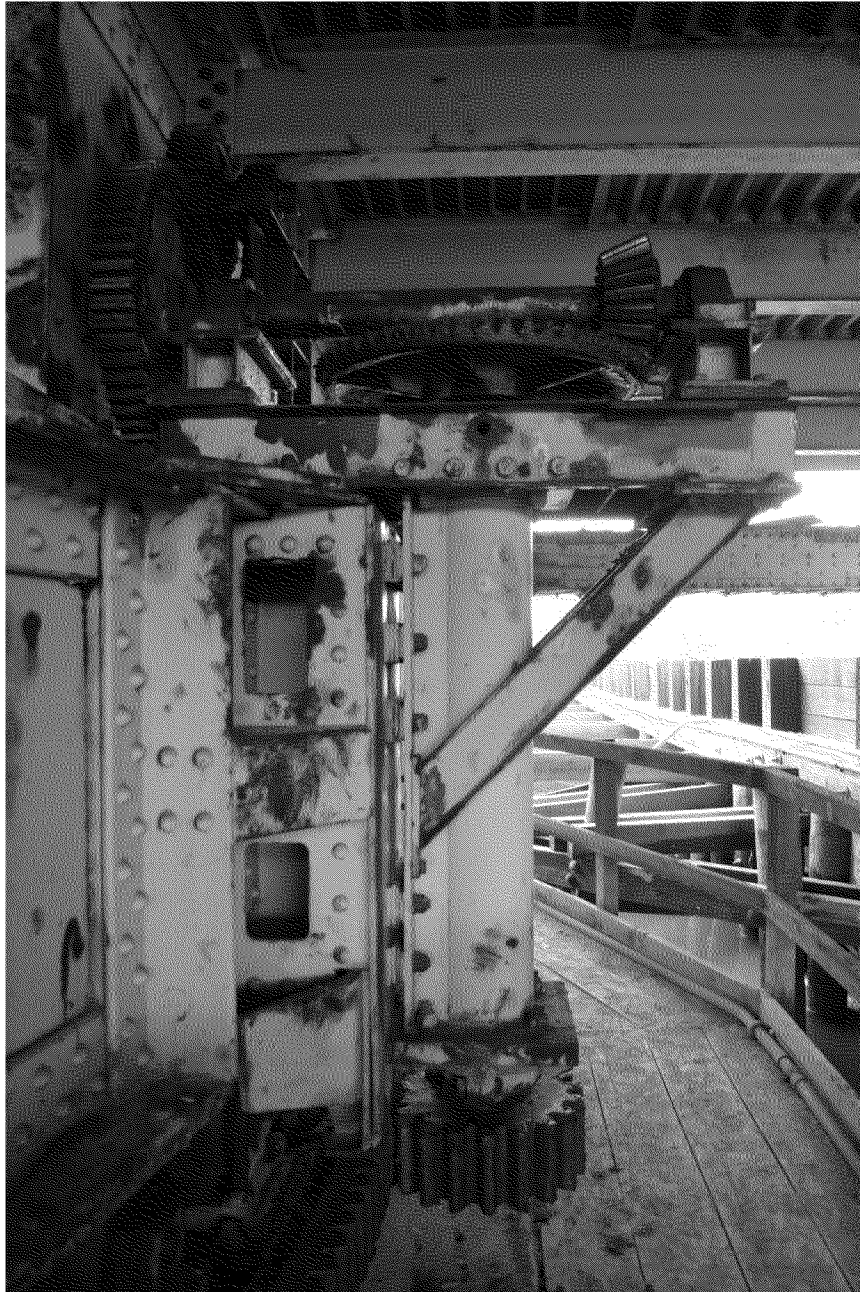
Most obvious cause of failure: one of two main shafts that turn the gear that turns the turntable, sheared for an as yet undiagnosed reason. A photo of the shaft on the Newark side of the bridge follows. This shaft is currently intact. It is topped by a series of gears that are driven by another shaft that runs to the center of the turntable. The gear at the bottom of this assembly spins the turntable.

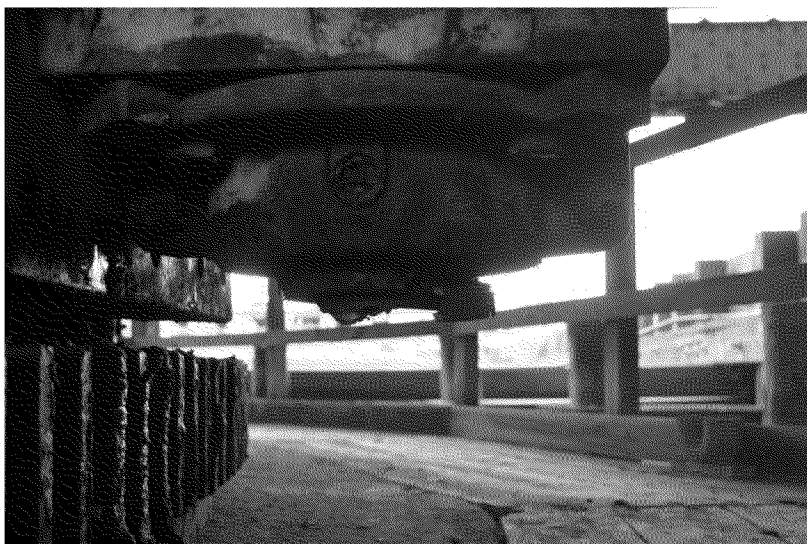
The same type of assembly on the Harrison side of the bridge is the one that failed. A photo of the bottom of the assembly where the shaft failed follows. This photo was taken after the bridge was closed. The failure occurred when it was in the open position which is why the gear is not currently under the shaft.

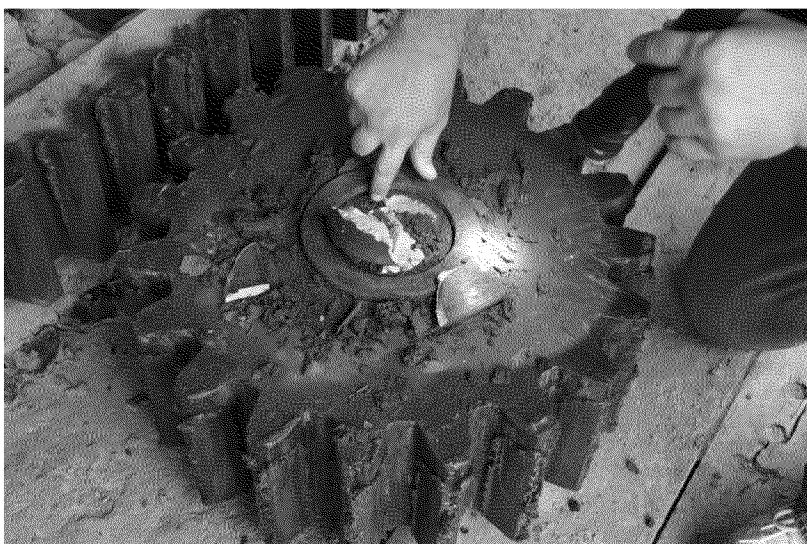
A photo of the gear in the place where it came off the shaft follows next. Hopefully a metallurgy expert can determine if this is a failure of the 100+ year old steel shaft, or a failure from there being unexpected resistance leading to excessive torque beyond the design capabilities of this gear set. Nobody mentioned failure of any shear pin within this assembly.

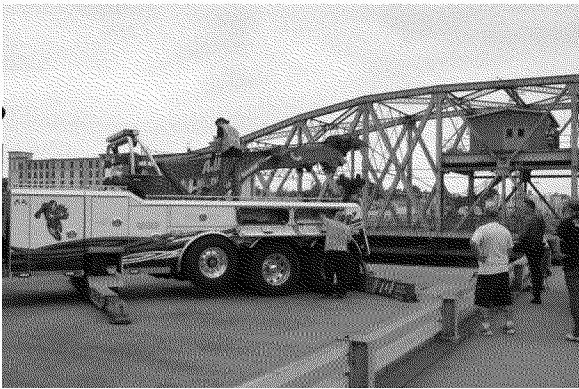
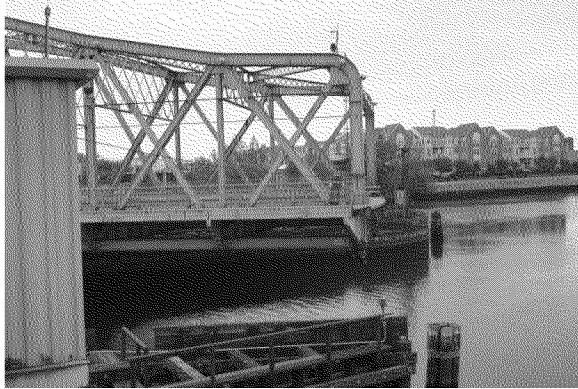
Because the Newark-side shaft appeared to be intact, the operators attempted to use the motor that controls those gears and shafts to close the bridge. But when that was attempted, the shaft would not turn, and a clunking sound could also be heard. While there were fears that the shaft was getting bound up, mechanical inspection and what appeared to be minimal resistance when the bridge was closed by a tow truck cable indicated the additional problem was elsewhere. Following are photos of the bridge being closed by the tow truck.

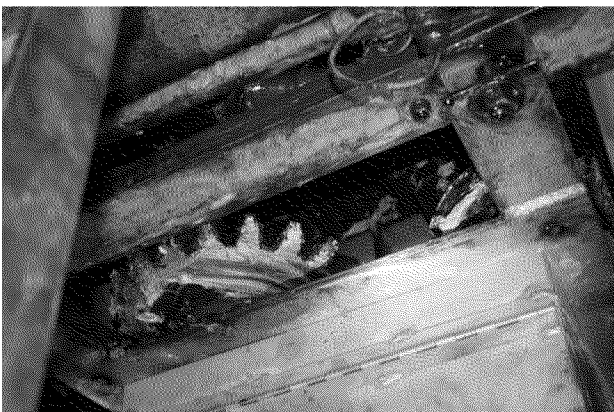
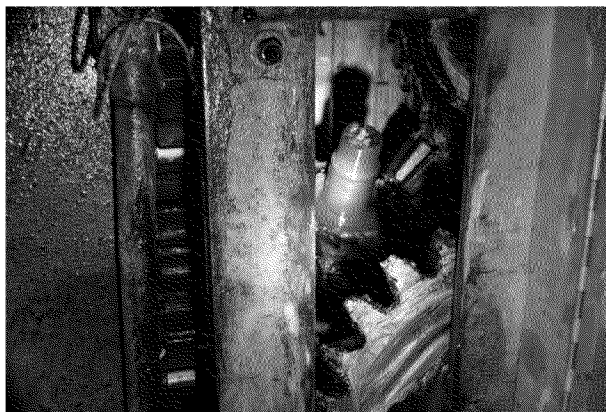
After the bridge was reset in the closed position, additional inspection of the drive shafts and gears close to the motor assemblies revealed that a smaller gear that would connect the main motor to the shaft that runs to the outer circle of the turntable, had somehow unscrewed itself. Photos of the displaced gear and the shaft on which it is normally placed follows.

Hudson County is currently attempting to get their mechanical contractor in to replace this gear and re-secure it with the screw coupling that had been holding it in place. That coupling was removed from the shelf of the casing during this inspection and is shown in the following photo.
